**14-18 Clarence
Place, Newport**

Bat Survey Report

Prepared by
**The Environmental
Dimension
Partnership Ltd**

October 2018
Report Reference
edp4560_r002a

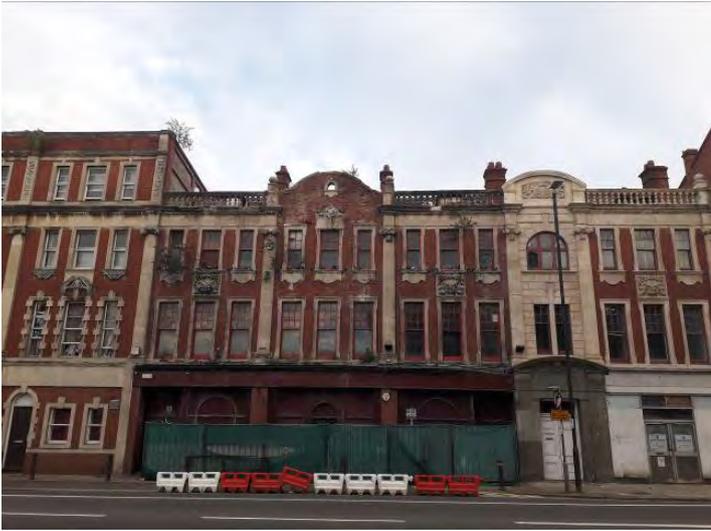
<p>Gaps in concrete facing between ground and first floor and damaged balustrade. These are unlikely to provide suitable ingress points into the building but may provide a suitable external cavity for crevice dwelling bats.</p> <p>All windows appear either well sealed or boarded up with no potential entry points for bats with the exception of a single rot hole within the wooden frame of a third storey window.</p>

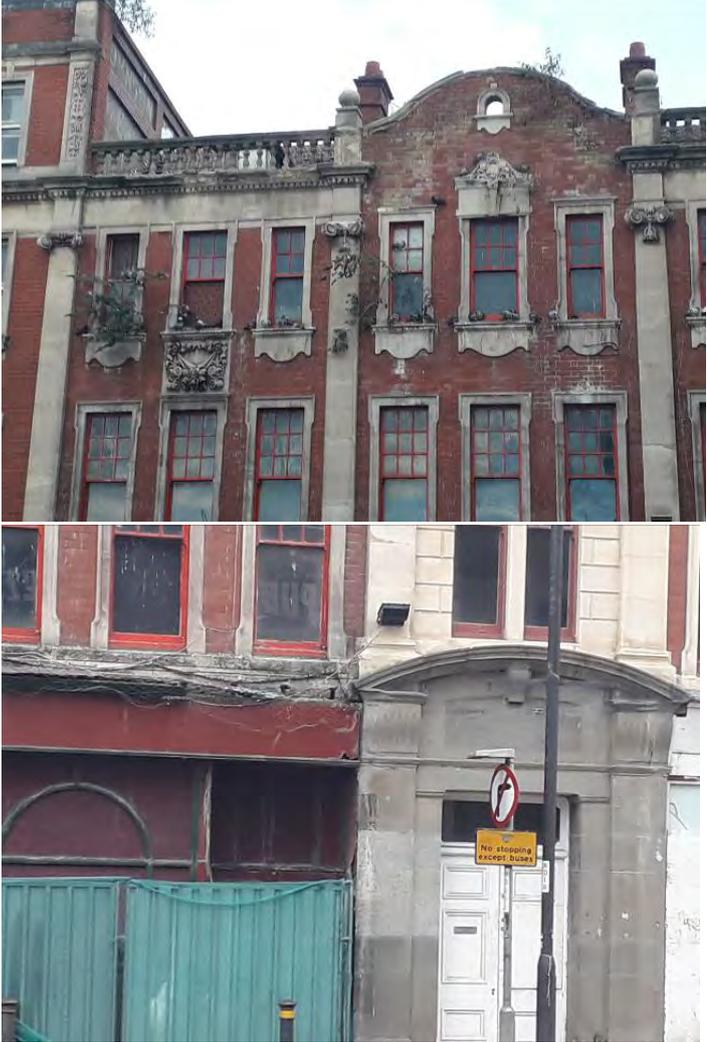
<p>Several slipped and missing roof tiles were noted and provide potential ingress points for bats into the interior of the buildings.</p>
Southern Elevation

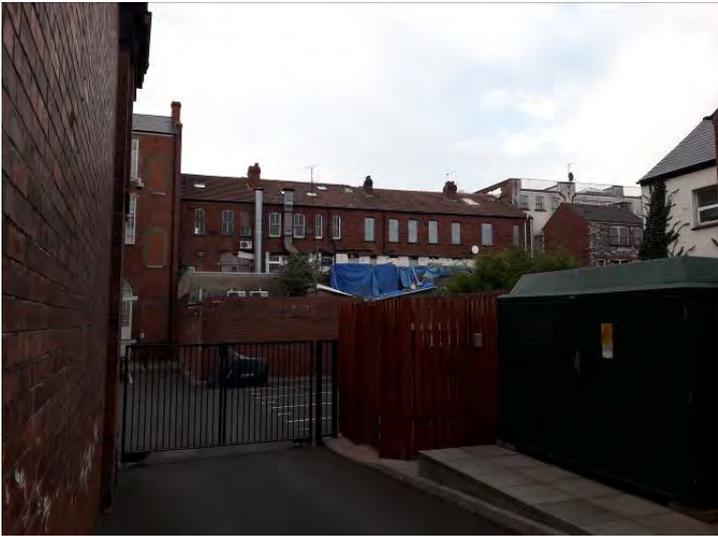
<p>Although the windows are boarded up, gaps between the top of the window and boarding were identified and offer access to the interior of the building for bats.</p> <p>Two large holes in third floor brickwork may provide suitable cavities for crevice dwelling bats.</p> <p>Several missing roof tiles noted and provide potential access internally.</p>

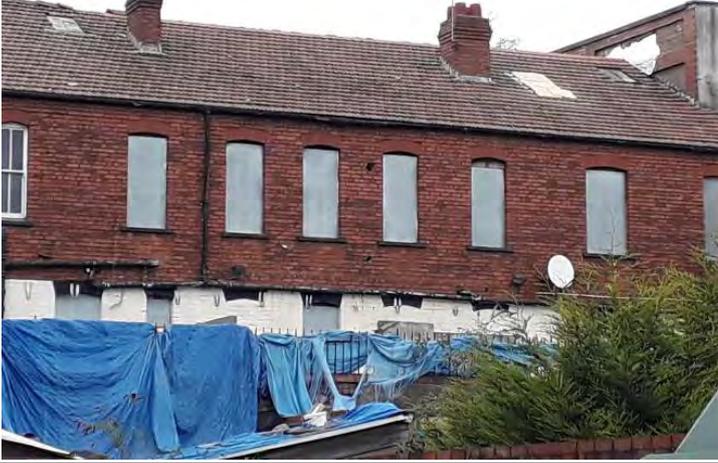
<p>Skylights in flat roof of rear extension with visible gaps. Several holes as a result of sagging roof and rotting timber.</p>
<p>Internal Features</p>

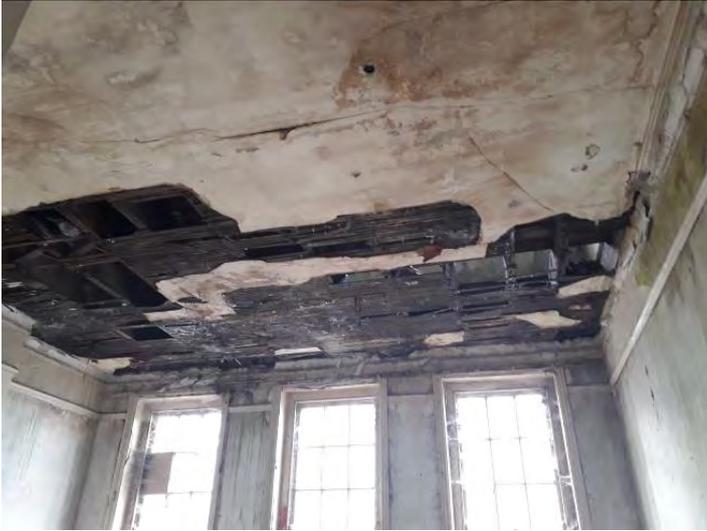
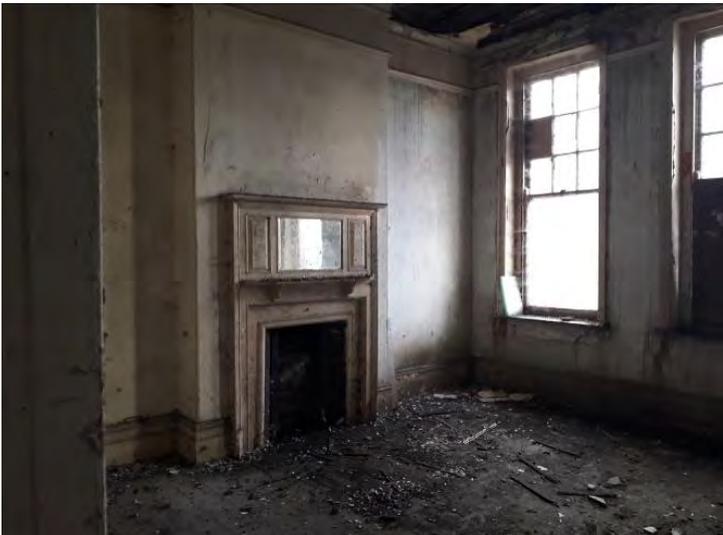
<p>Interior of building (first floor) is relatively well lit and drafty with significant water ingress creating damp conditions not favourable to roosting bats. Missing floorboards/ceiling presumably provides access to all floor through the roof. Pigeon was noted roosting within the building confirming that internal access is available. Several dead pigeons littered floor. Open fireplaces may provide potential roosting features.</p> <p>No evidence of bats found.</p>

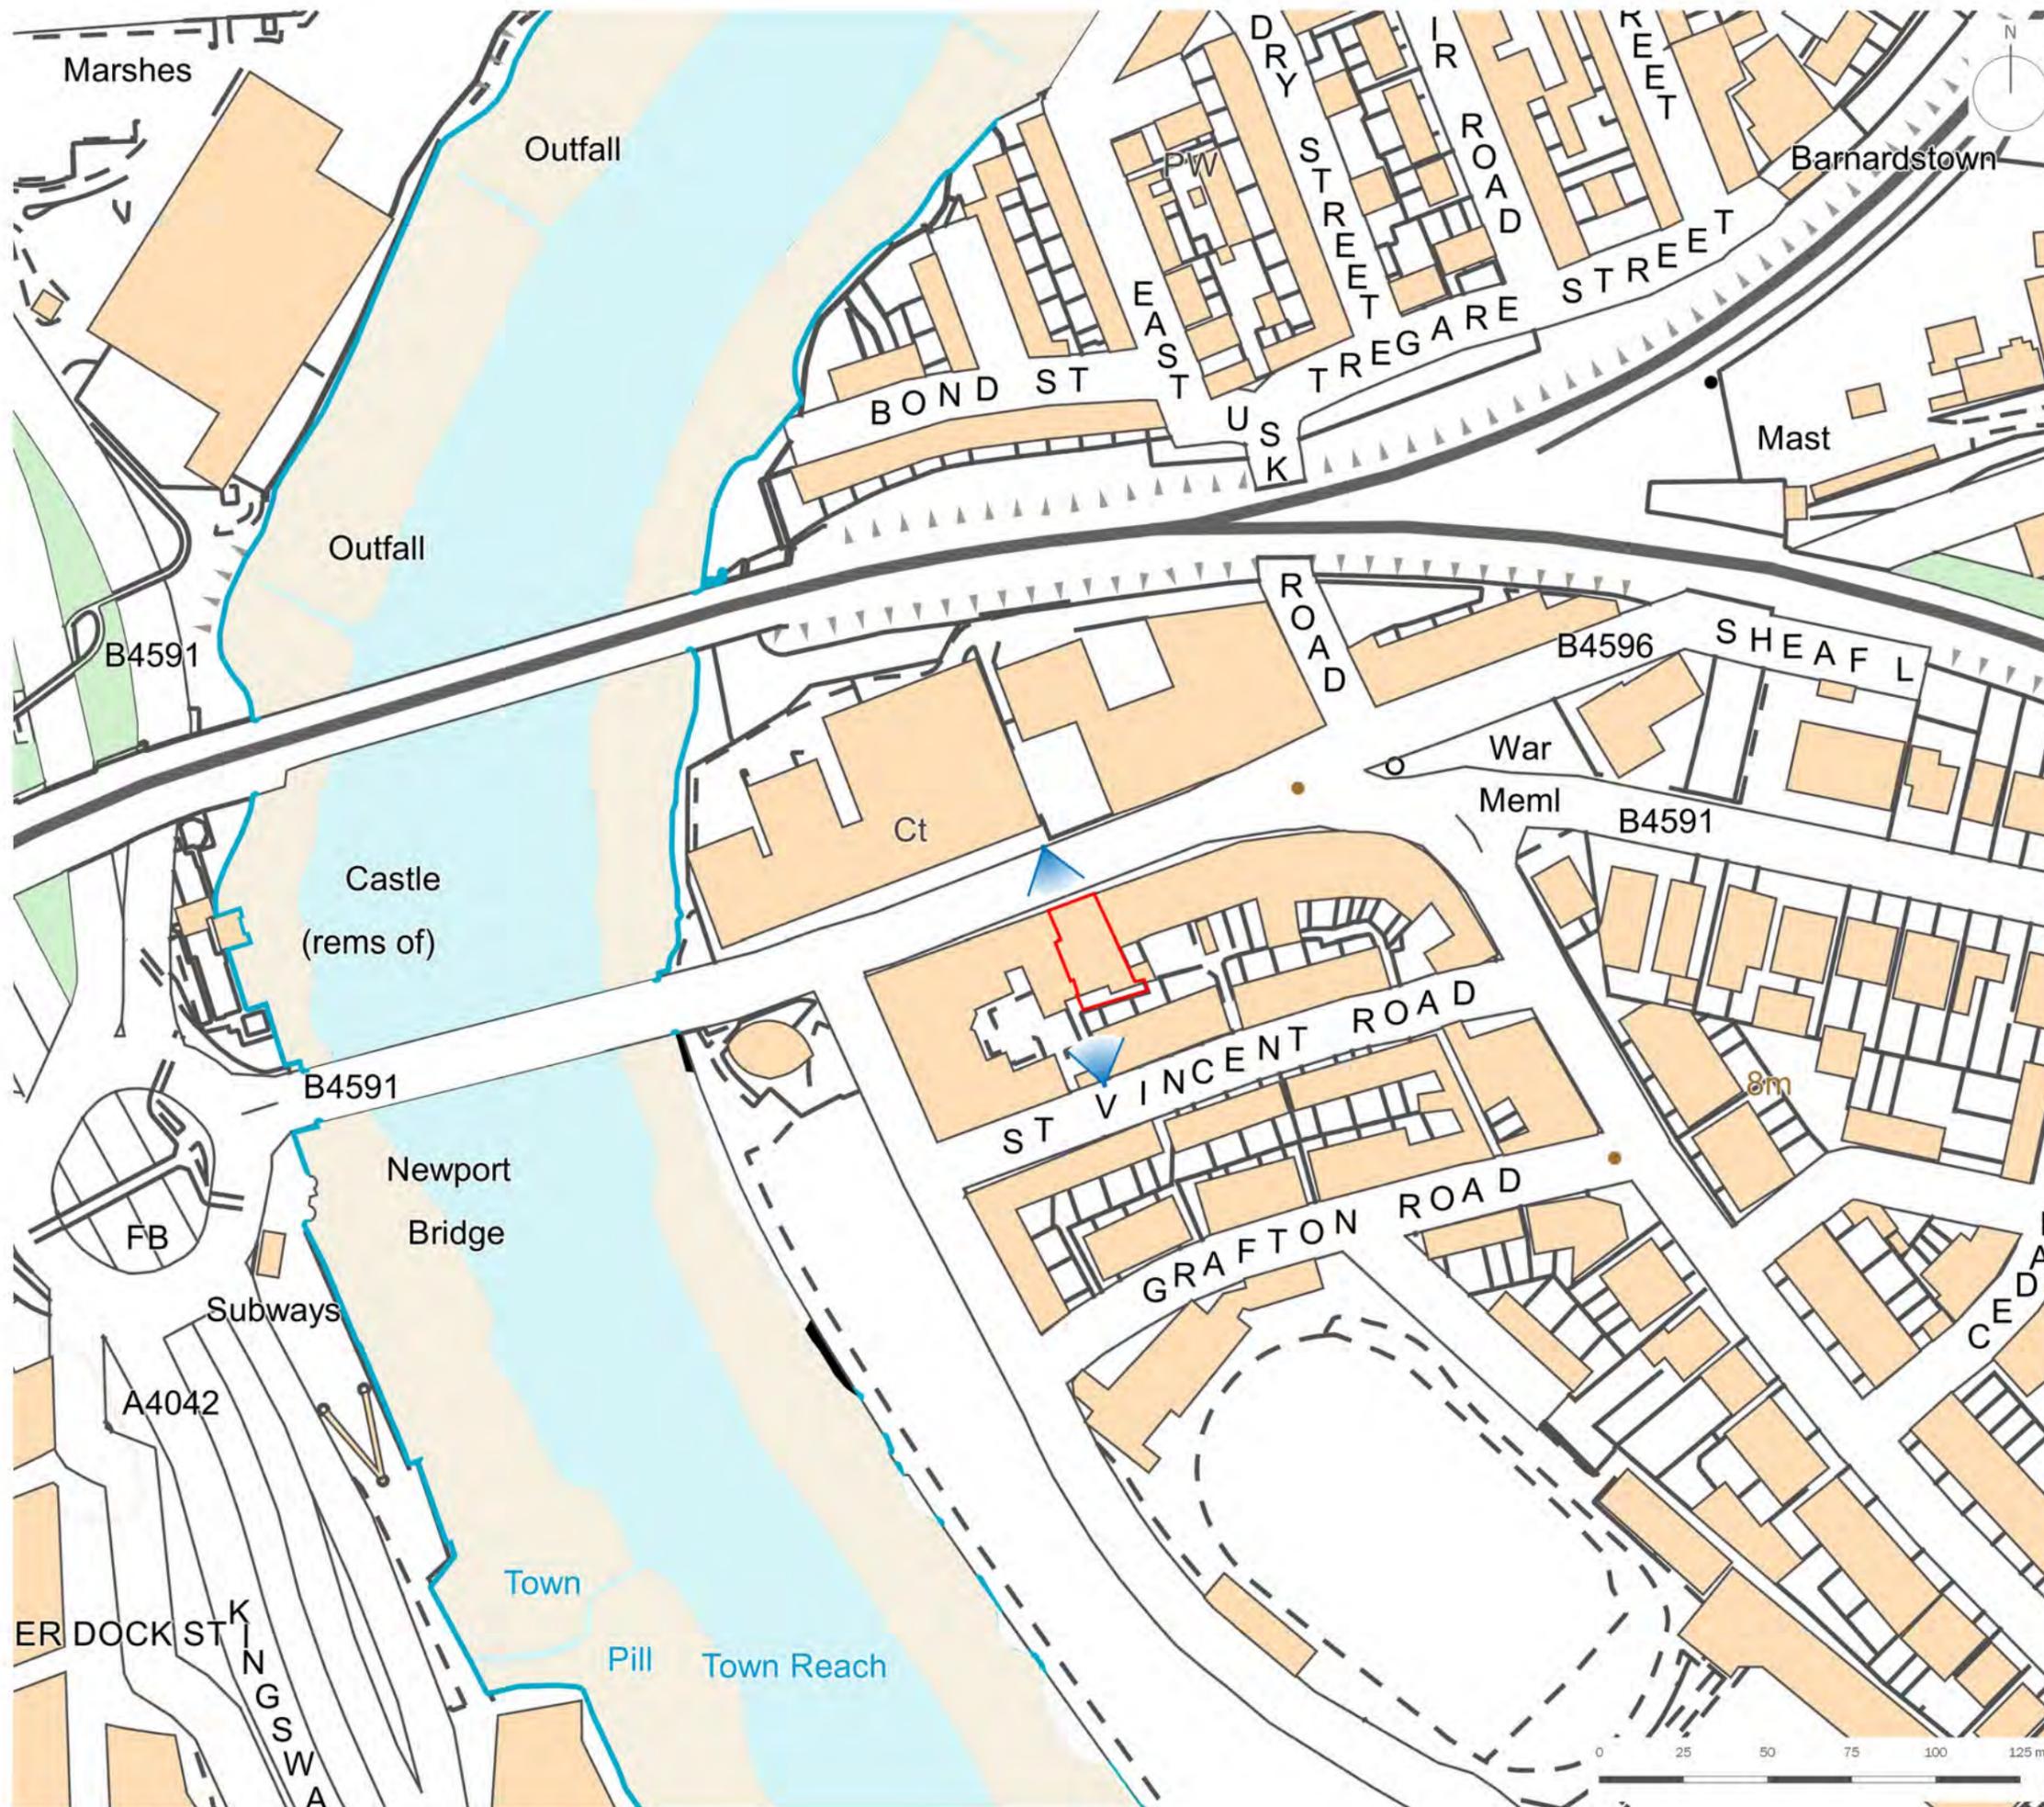
Plan EDP 1 Bat Roost Assessment Surveyor Locations
(edp4560_d001 01 October 2018 AG/EW)

- Redline Boundary
- ▶ Surveyor Locations
